# Status of EPIC operations

Pedro Calderón Riaño, ESAC  
Mallorca BOC meeting  
29-30 March 2011

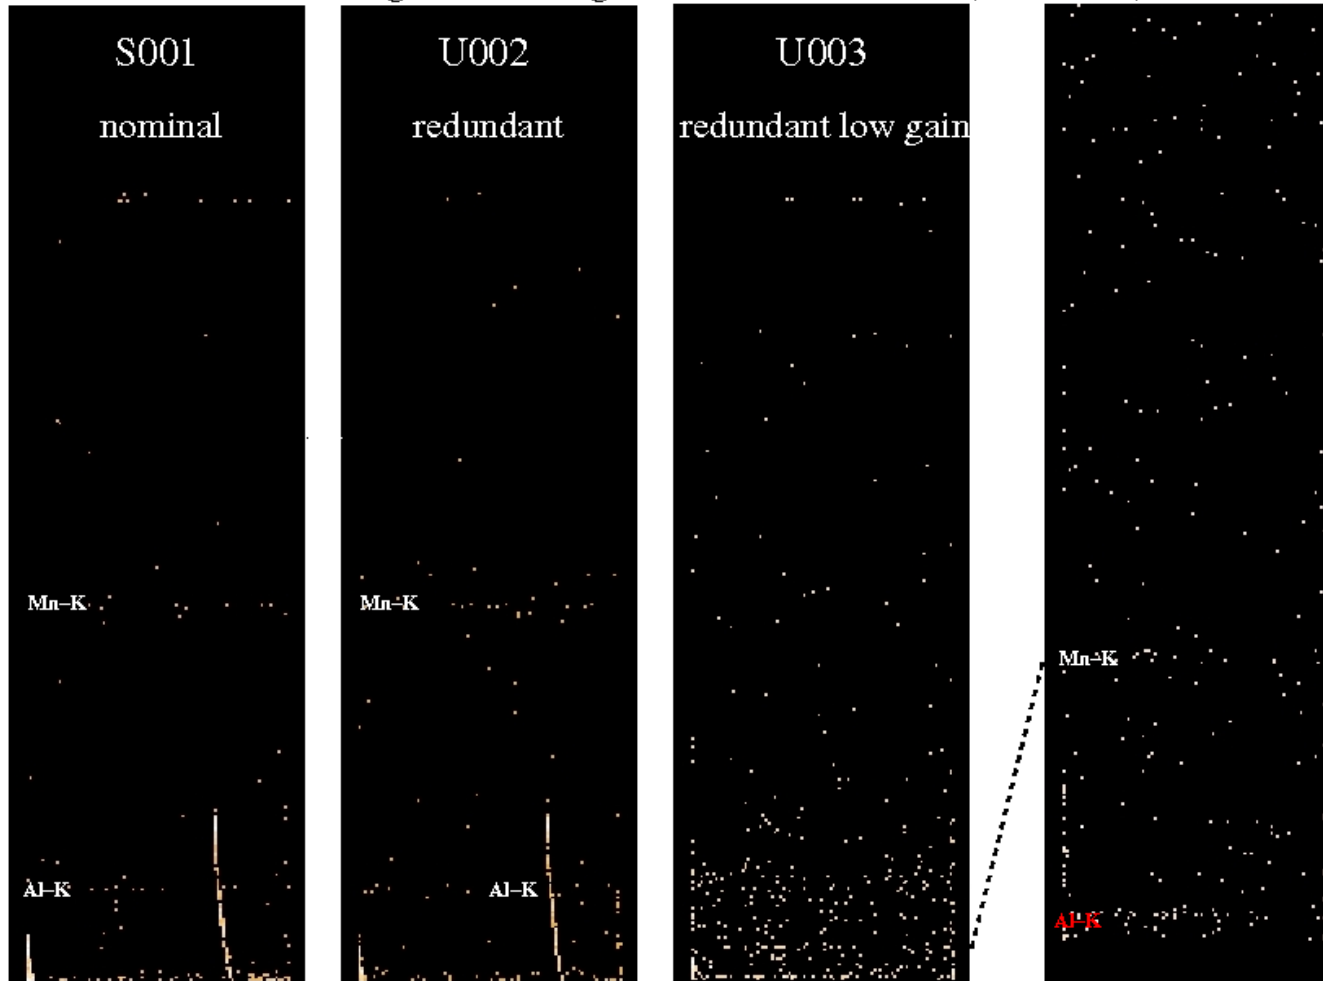
MOS1 Timing mode low gain test: 0655450201 (rev. 2010)

- **EOR-8;** Test for MOS1 timing mode echo due to meteorite column
  - Performed a Timing Low Gain Cal\_Closed test exposure
  - OCR#2046, 29 Nov 2010.

- The complex configuration required use the redundant Analog Chain, so a reference exposure using the redundant chain in normal gain was also performed.
  - Also another 3 test were required for verify and refine the instrument configuration, all it performed manually.

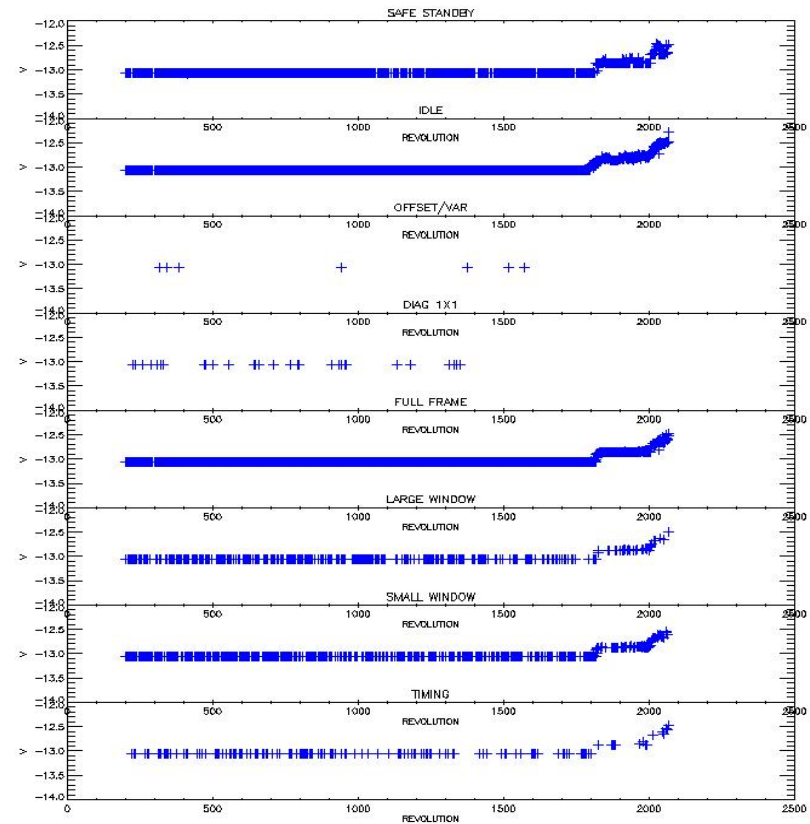
E1078 C EMAE -13V LINE (Rev: 200-2066)

- The secondary power lines voltage degradation, started on 2009, continue increasing
- 'Reset' at the change to MOS2 B

- Given the heavy increase of wrong telemetry and the voltage degradation, a decision is taken for change nominal operations to the redundant electronic MOS 2 B.

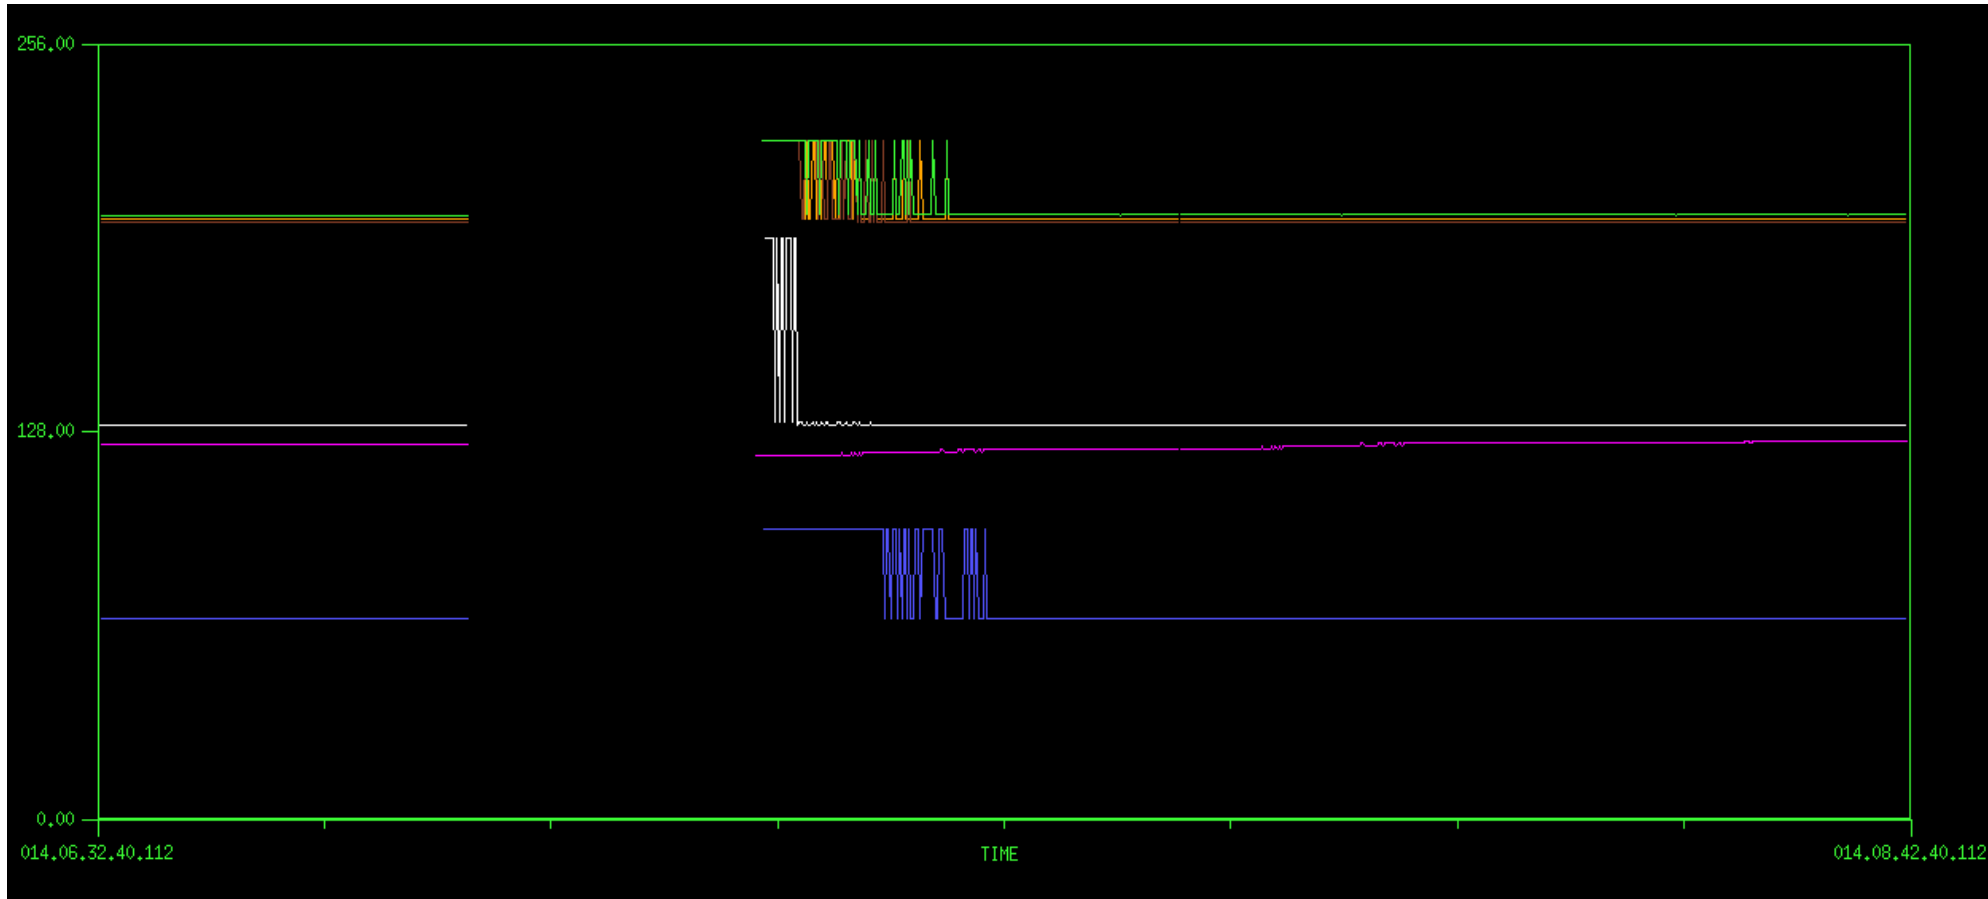
# MOS 2 tlm jumps at switch on

- Some telemetry parameter show peaks of raw digital wrong values.
- This start happening at the switch ON after eclipse, and last from 31 seconds to 21 minutes. Solved by itself
- Started happening after Winter eclipse #3 on 27 Dec 2010, and stopped after the last eclipse #12 on 14 Jan 2011.
- Reappear again in 5 March on perigee, at the lowers temperatures of the orbit.
- On 20 March started happening every time that the instrument was in Idle, and even when observing.
- The parameters affected are all from K1076 to K1090.
  - They are voltages and temperatures from EMAE, EMVC and EMCR.
  - They have in common an analog to digital converter into EMCR, and are all the lines that enter to that A/D.
  - The raw value jump to bit patterns were the  $2^5$  bit is usually the erroneous one. After that all the other LSBs stuck to a fixed value.

➤ Before ... Eclipse/Off Wrong tlm return to good telemetry

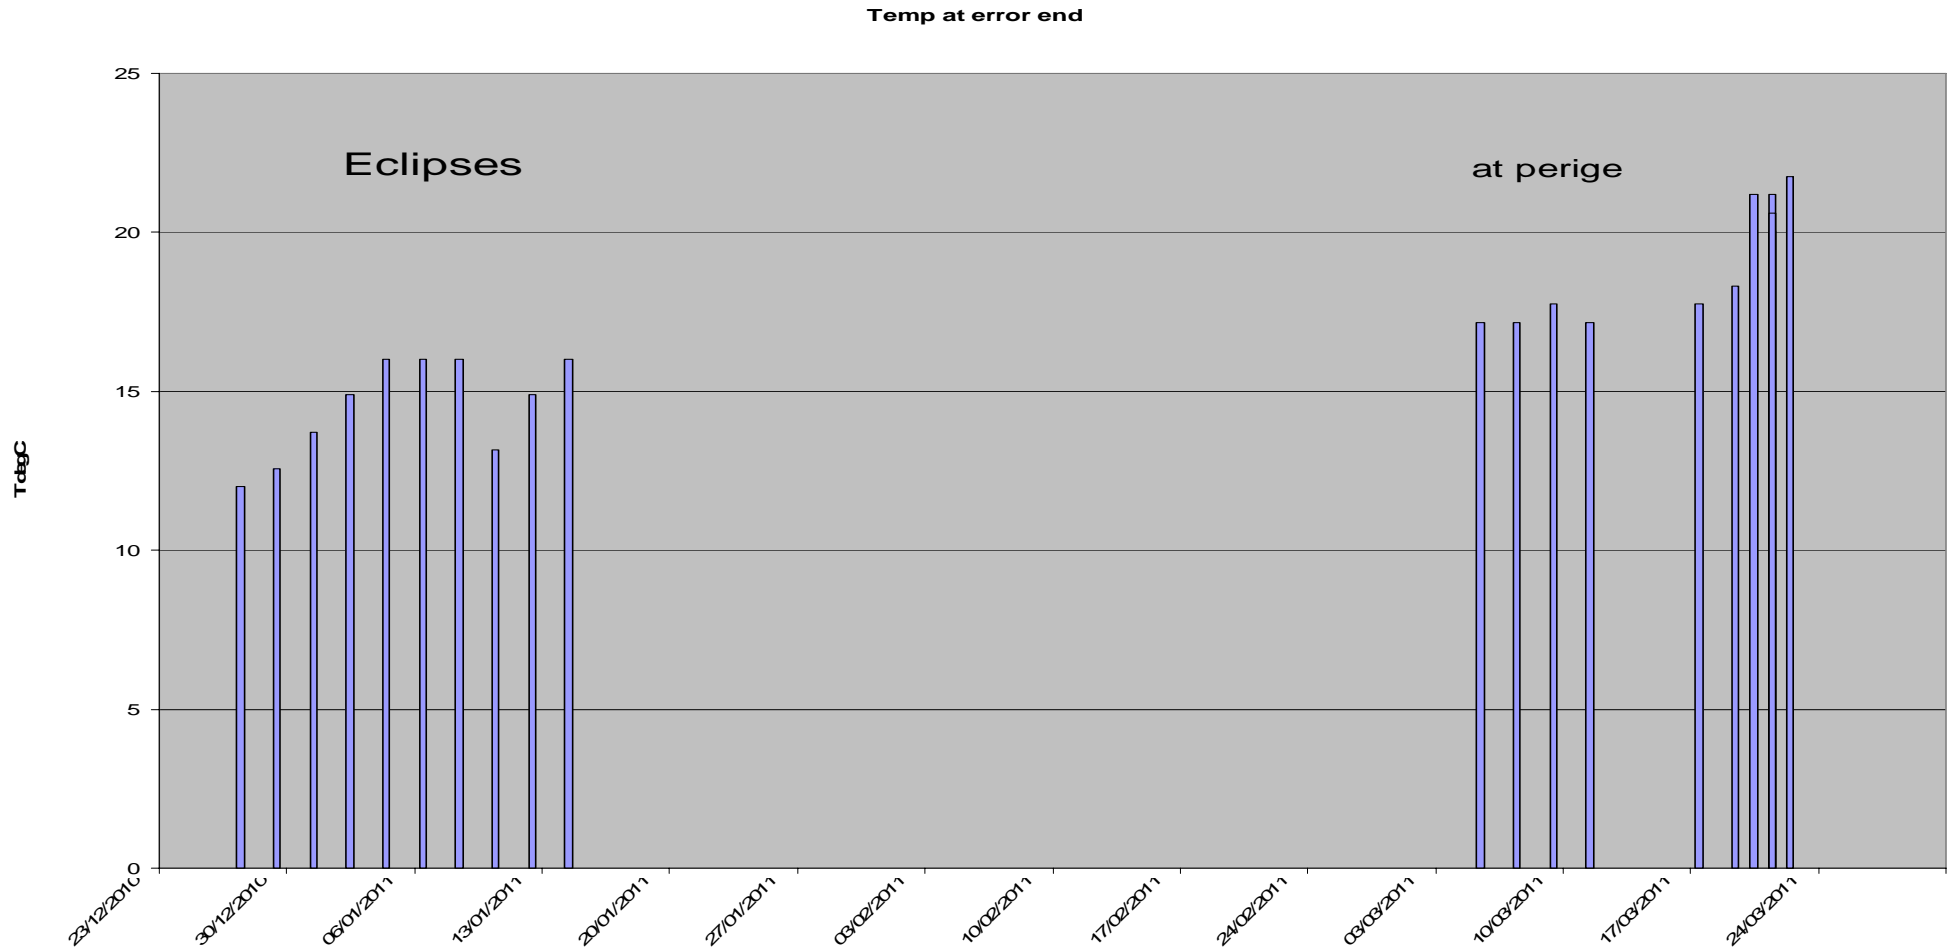
# Errors along time and versus temp

- The problem is within the conversion to digital of the measurement (raw data), not with the physical value measured (engineering values).
- Have a relation with low temperatures
  - But the sensors and heaters are box wide, giving not enough information about the conditions in the suspected chip.
- A test was done on 6 Jan. A switch off/on so quick as for avoid thermal changes. No wrong telemetry appear.
- MOS 2B (the redundant electronic) was tested (powered) for fist time since launch. OCR#2084, 12 January 2011.
  - The redundant electronic is the only solution to the wrong tlm problem.
  - It is OK. A test calibration observation was performed and look good.

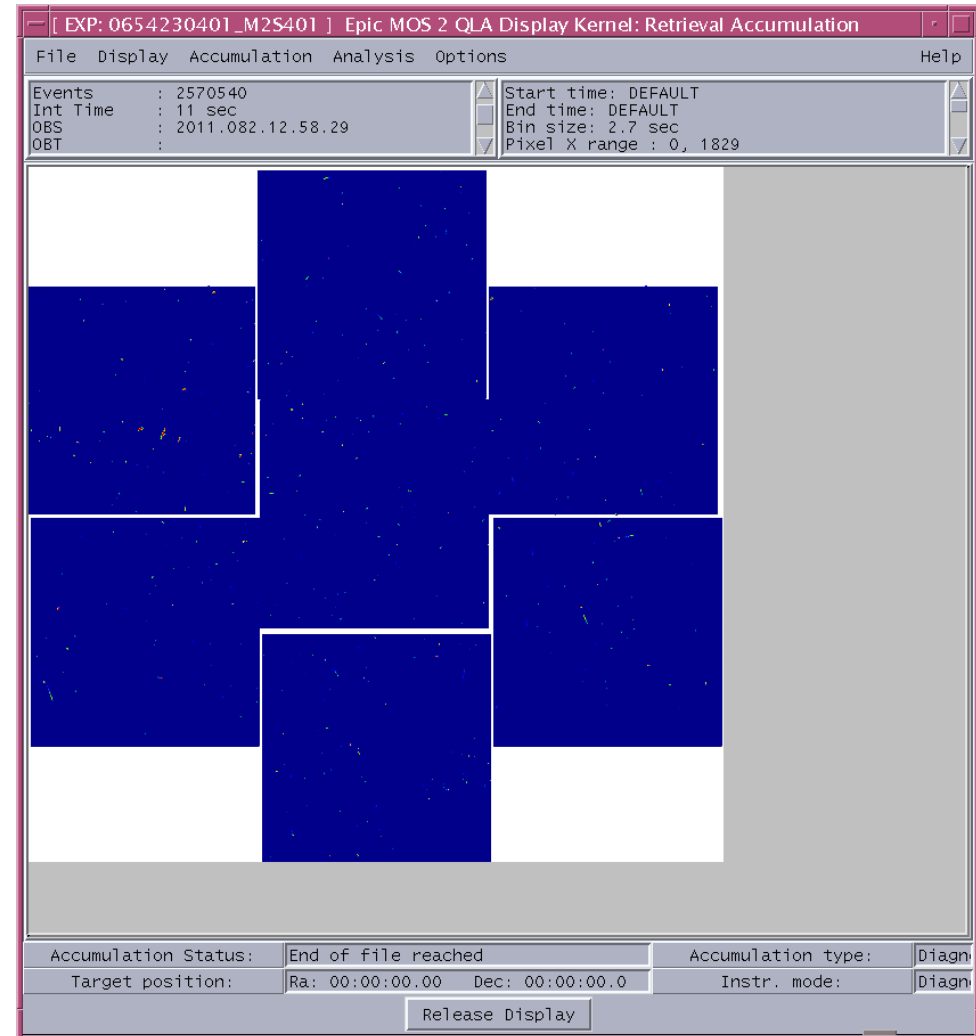
- The change of operations was successful
- MOS2B have no degradation into the secondary power lines
- Almost all the ground segment is ready for operate the MOS2B
  - Minor problems solved manually
  - Next OBD will return all to automatic
  - Some changes identified for eclipse operations (next eclipse in June)
- First exposures look nice
  - Diagnostics 1X1 =>
- No changes are expected in calibration
